# Blood Road Muck Mitigation Site

LRB-2019-01208

Ducks Unlimited New York In-Lieu Fee Program  
LRB-2010-00673 (ILFP)

**DATE: 23 June 2021**

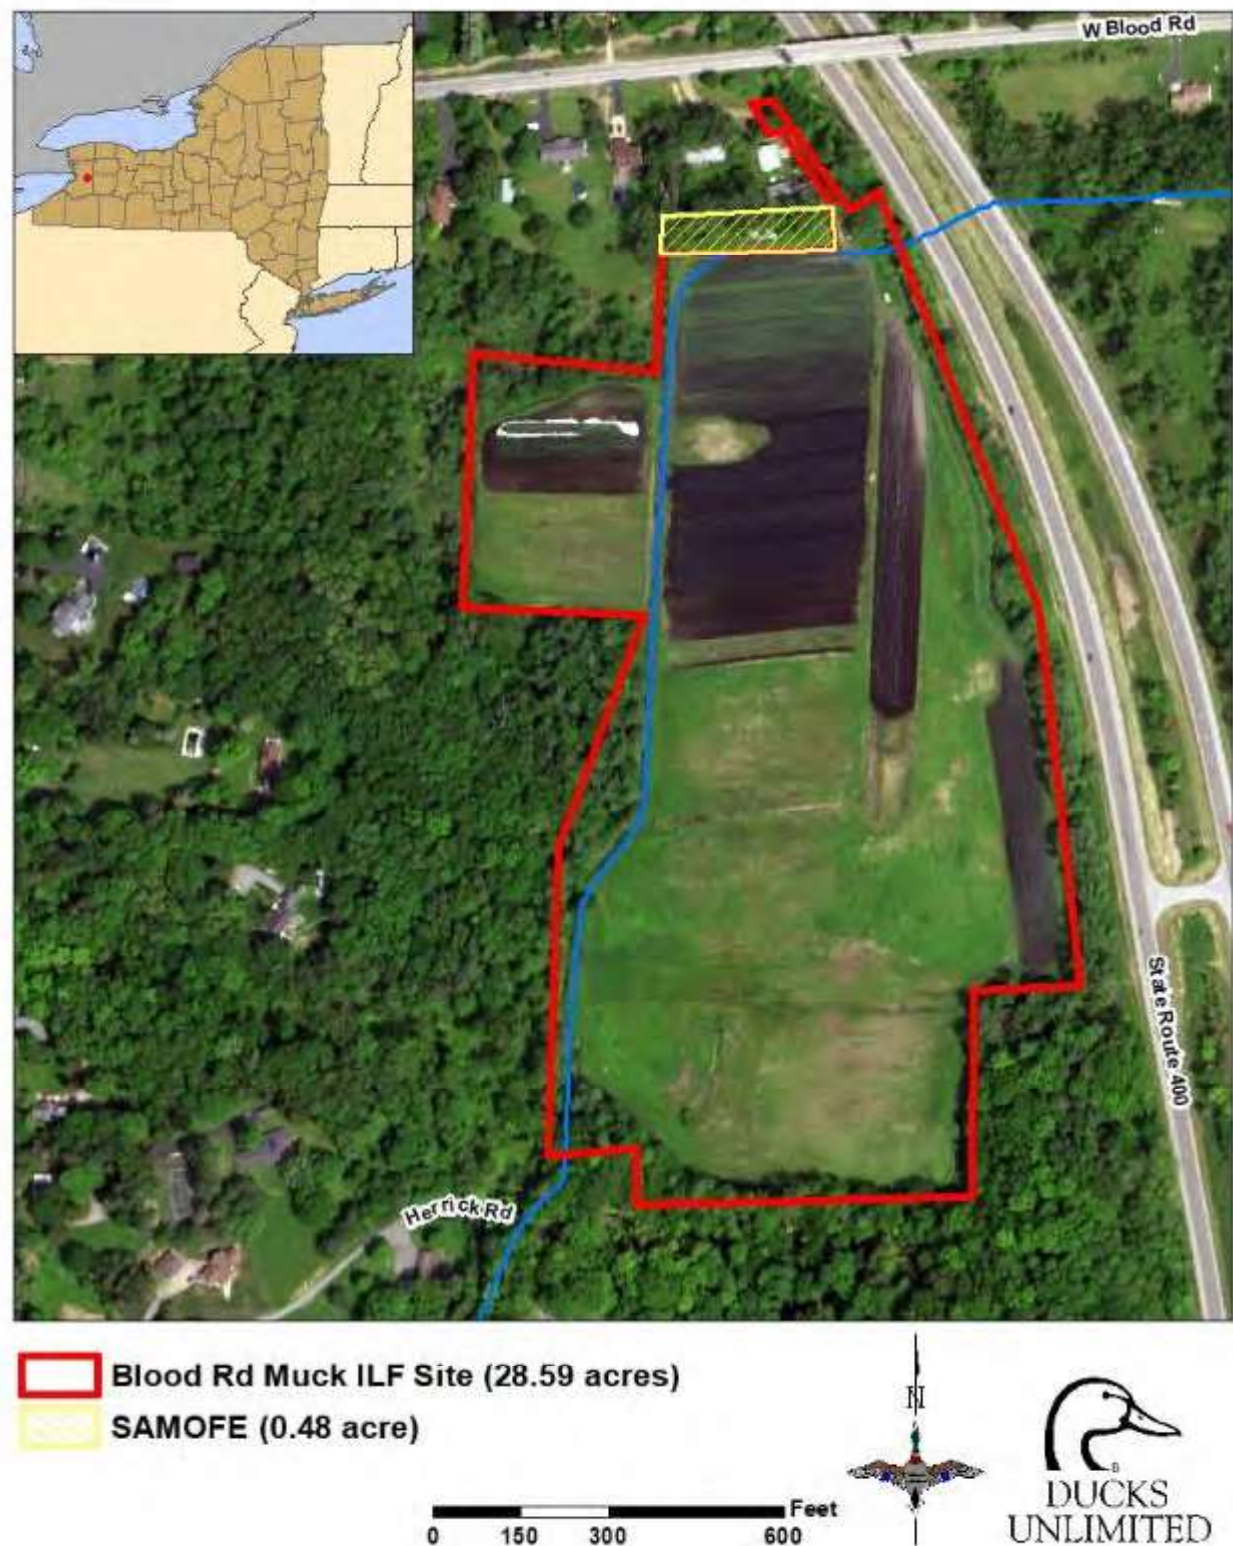
**Figure 2 View of the Site.**

The 28.59-acre property is owned by DU Lands LLC. (DUL). DUL is a wholly owned subsidiary of Ducks Unlimited.

The geographic boundaries of the Site correspond to the 28.59-acre area to be placed under a conservation easement (red-line) as depicted in Figure 2, and in Appendix D. The Site is bounded on the east by State Route 400. The remainder of the site borders private land. A small area, excluded from the credit production, will serve as off-road parking (Appendix B).

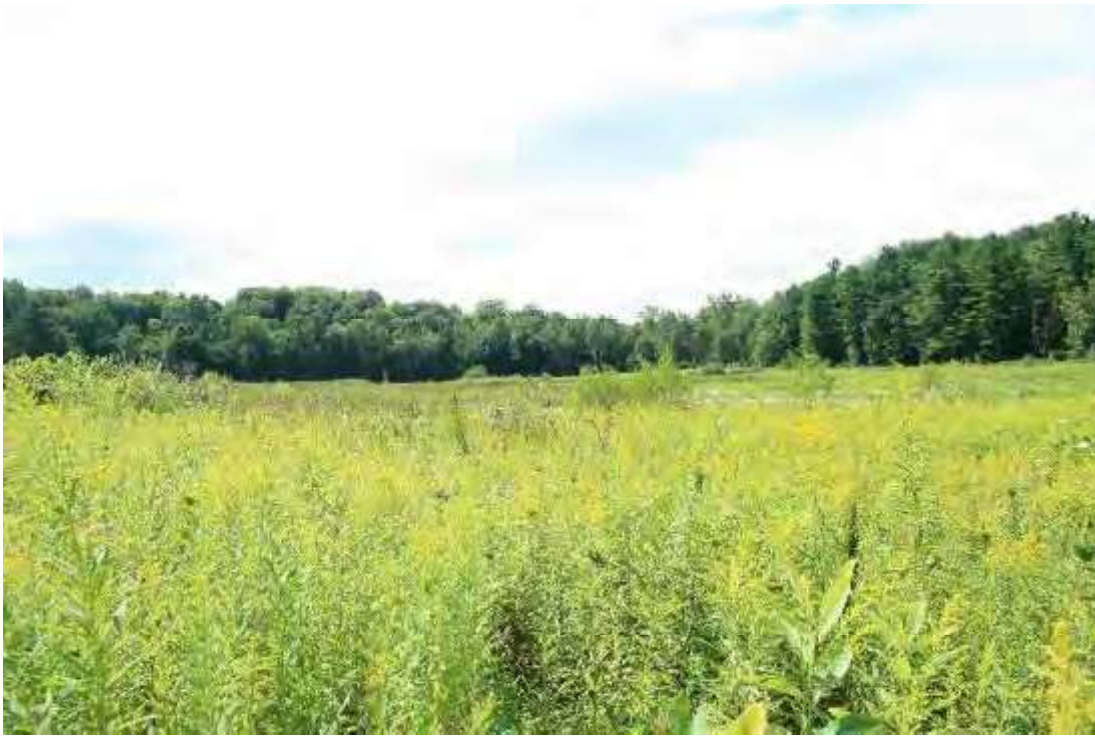
Agricultural drainage remains functional in the northern and eastern portions of the muck field, resulting in a water table below 22". These areas are currently dominated by FACU species and have the largest reestablishment potential. Photo taken August 27, 2019.

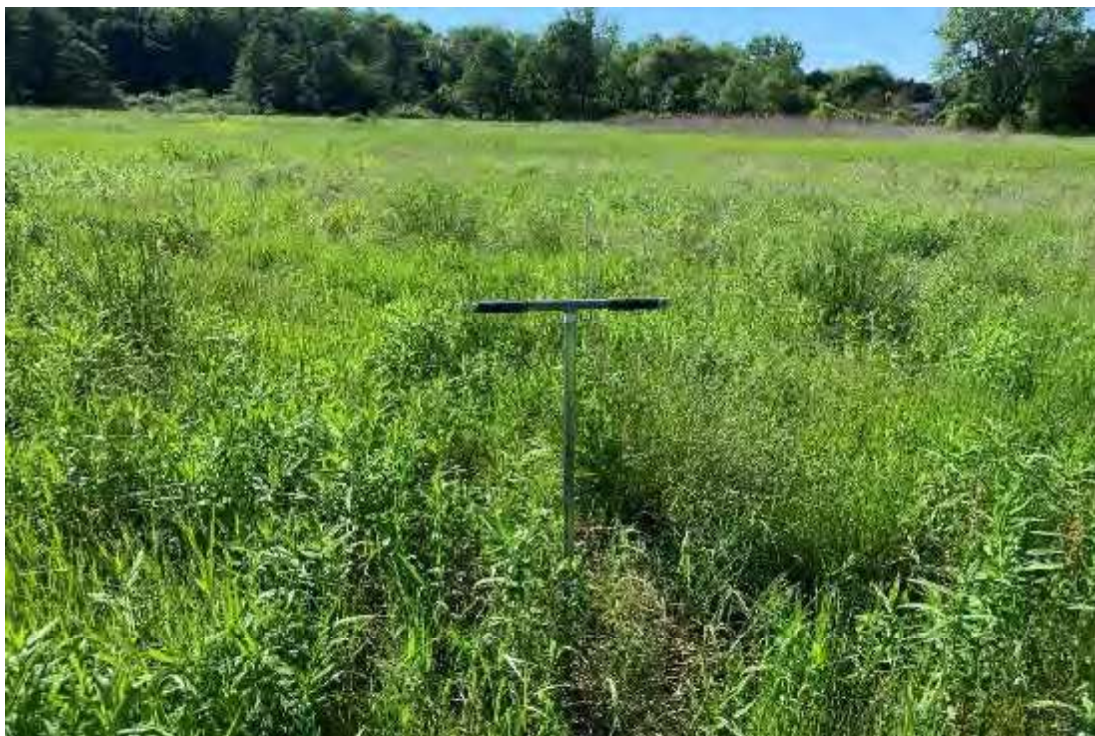
Much of the central and southern portions of the muck field delineated as wetland. Photo taken June 8, 2020.

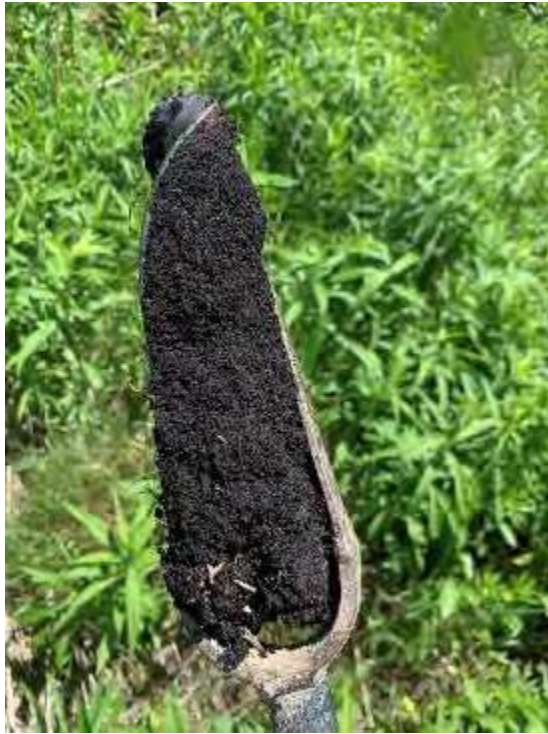
Muck soils were at least 20" deep across the majority of the site.

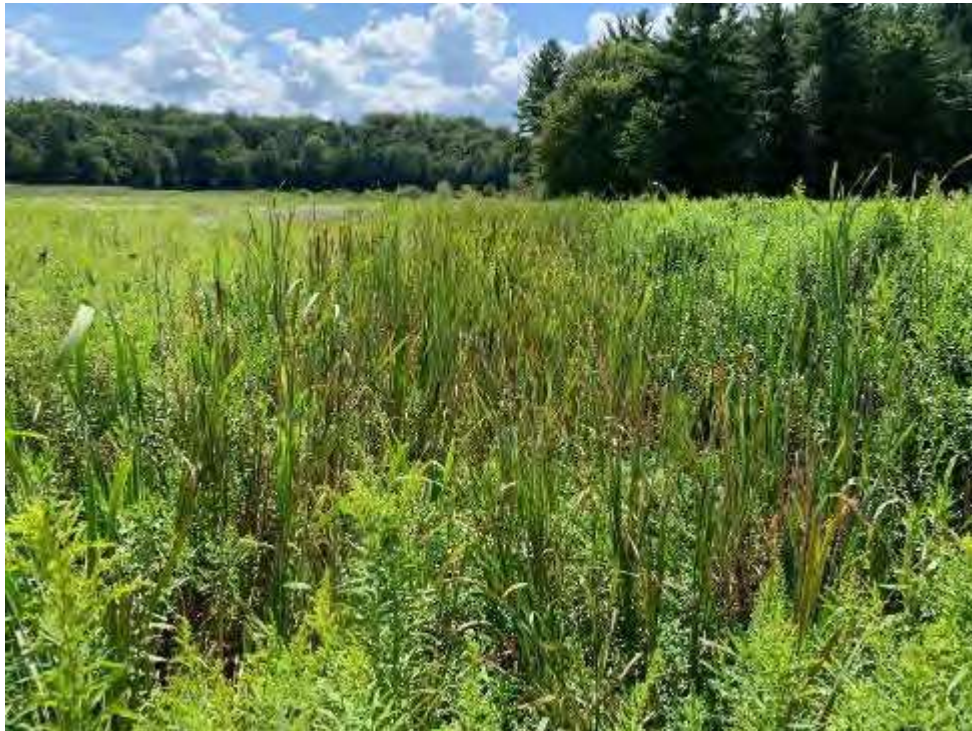
An unnamed tributary to Buffalo Creek that has been channelized to provide drainage to the site, while existing perimeter and interior drainage ditches were tied into the stream. Planned grading adjacent to this stream will allow high flows to enter and remain on the site, without disturbing the stream itself. Photo taken August 17, 2020.

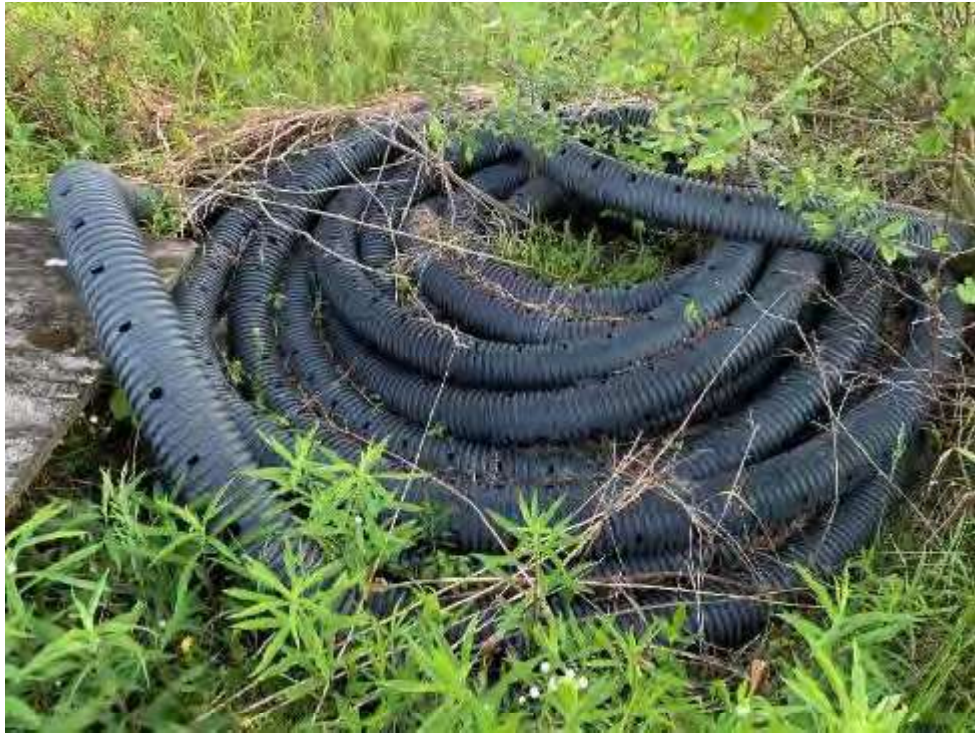
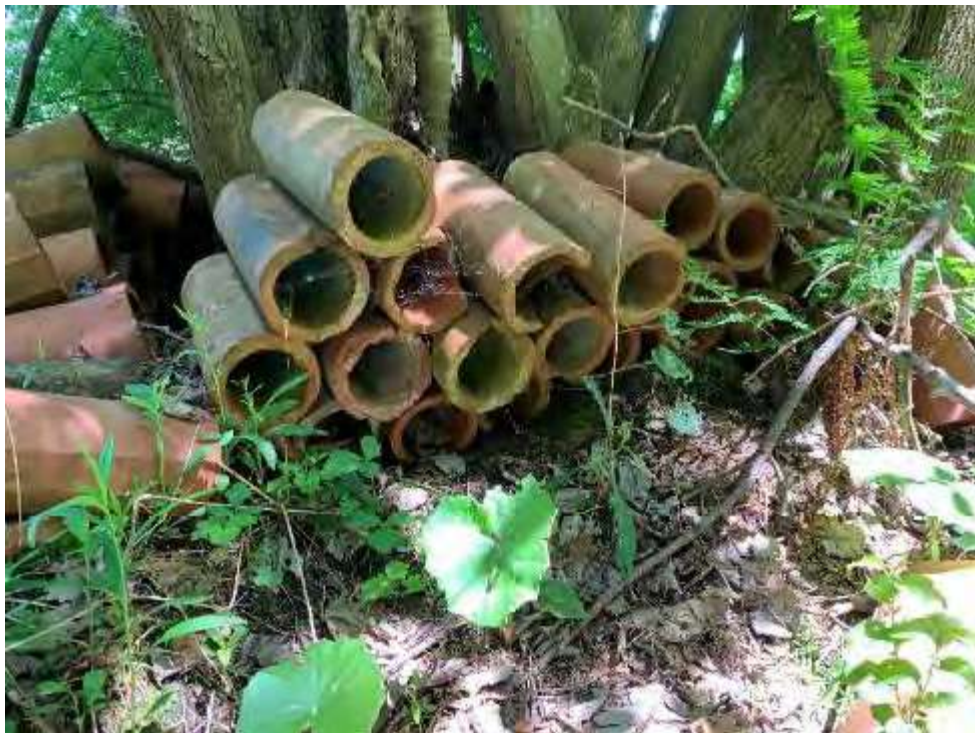
Evidence of tile drainage can be seen across the site. During construction, existing tile lines will be located and disrupted. Photos taken June 8, 2020.

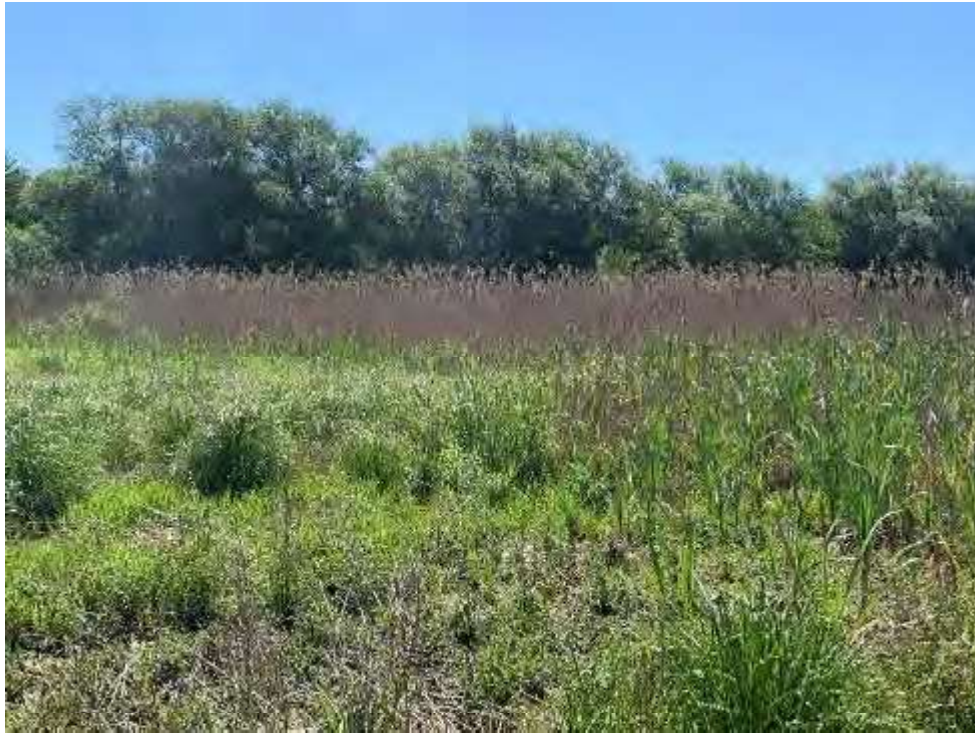
In conjunction with construction activities, invasive species will be mowed prior to a broad-cast herbicide application. Photo taken June 9, 2020.

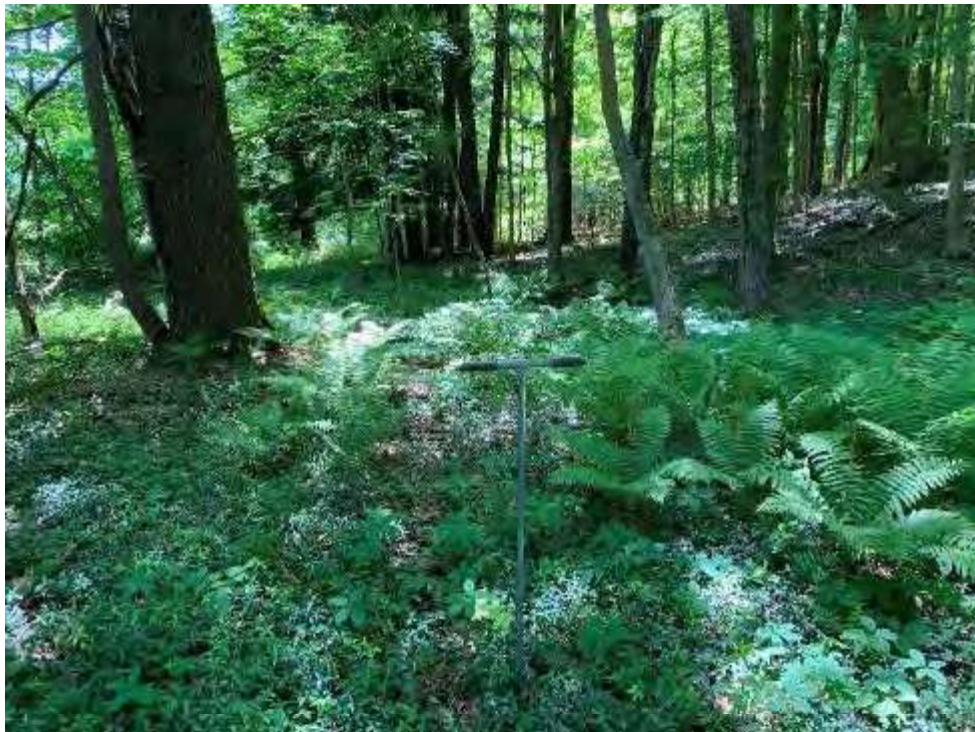
Upland forest borders the muck field to the west and south. Photo taken June 8, 2020.

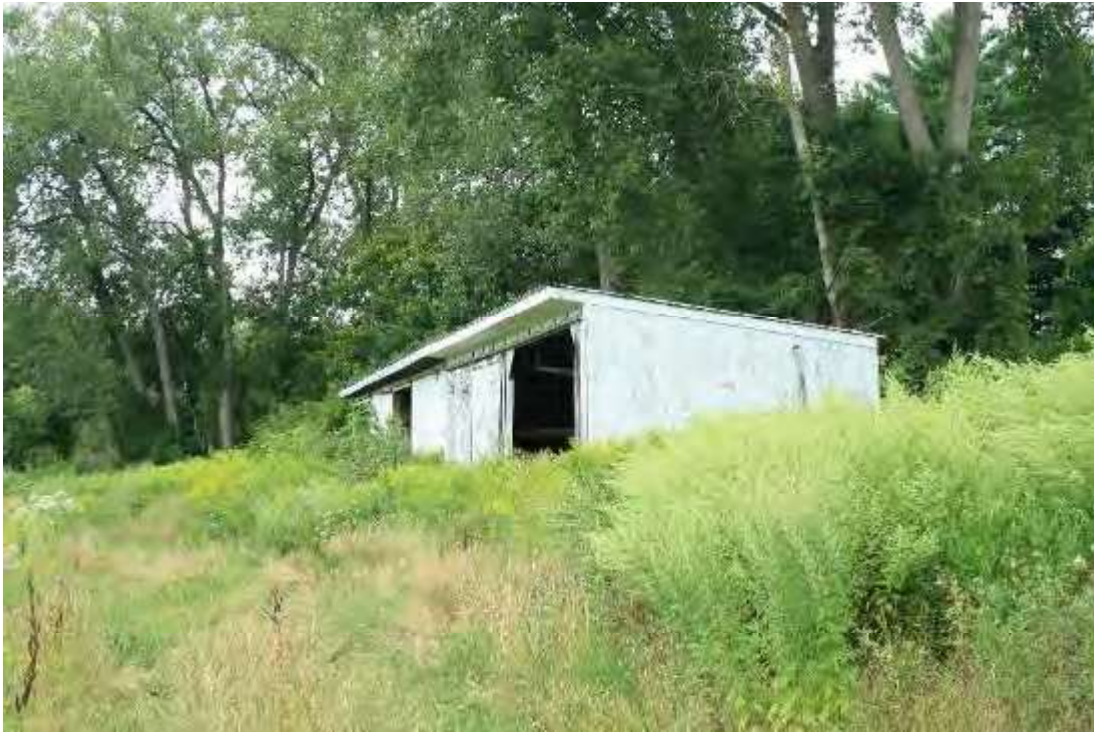
The New York State Office of Parks, Recreation and Historic Preservation has approved the plan to remove a pole barn located within the Site Access and Overland Flowage Easement Area owned by the neighboring property owner. Photo taken August 27, 2019.

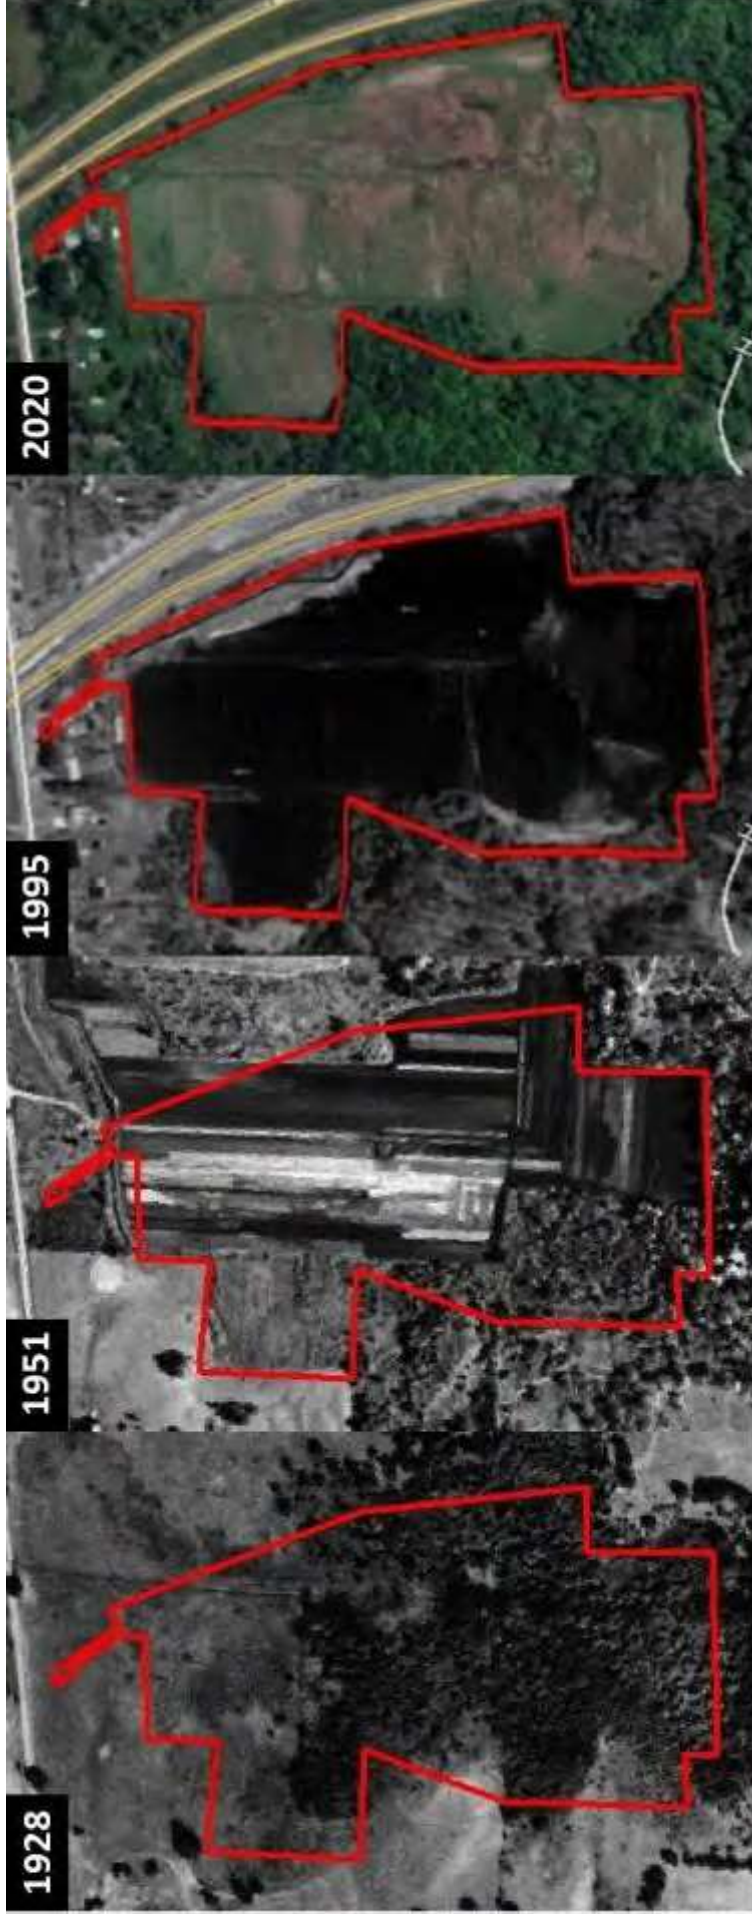
**Figure 3 Historical Aerial Photos from Blood Road Muck.**

Wetlands on the property were cleared and drained some time between 1928 and 1951, and was continuously in agriculture through the 1990's. From 2005 and 2018 portions of the muck field had been rotated in and out of fruit and vegetable crops.

From a review of aerial photography dating back to 1928, fields within the Site have been continuously maintained for agricultural production (Figure 3). Additional land was cleared for agriculture between 1928 and 1995. More recent aerial photos indicate that portions of the muck field have been rotated in and out of fruit and vegetable production from 2005 to 2018. On-site reviews in August 2019 and June through September 2020 provided evidence of previous hydrological modifications, including ditching and tile drainage. Much of the Site's cropland areas appear to have historically supported more extensive wetlands prior to drainage and tillage activities. There are no known hazardous material sites located on or within the vicinity of the Site.

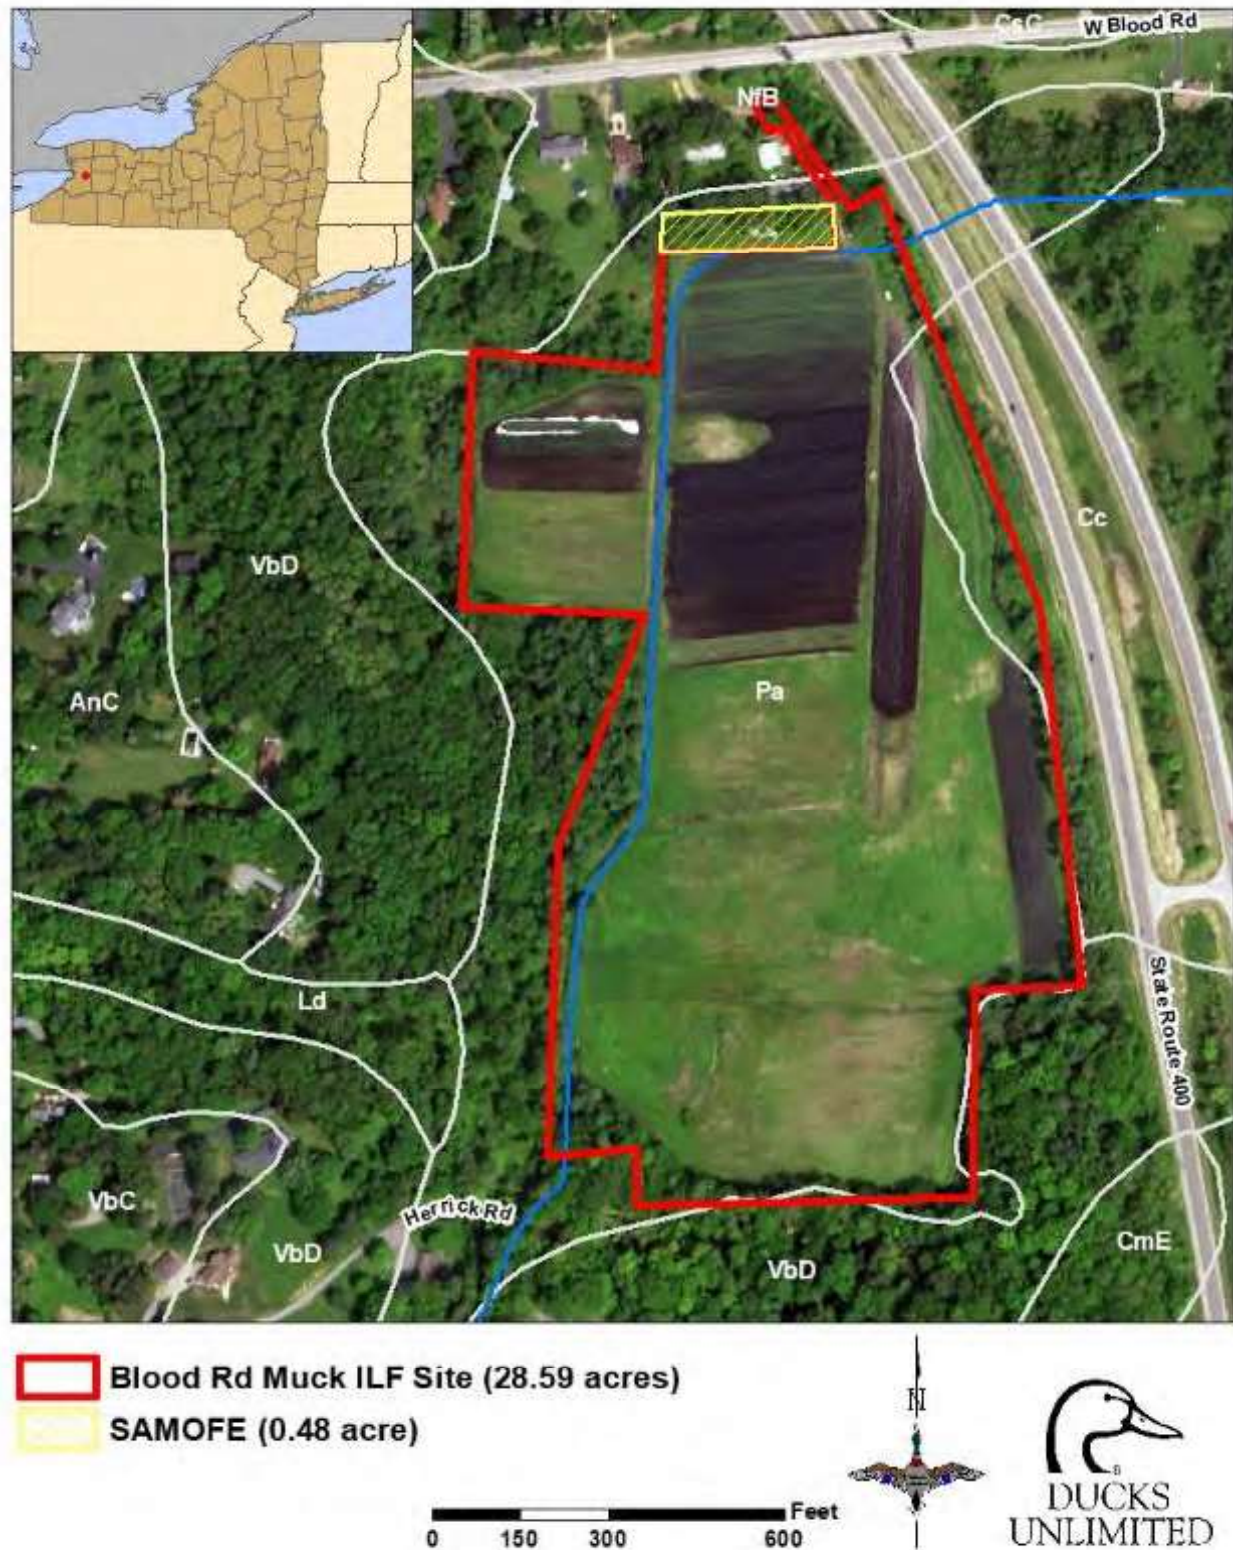
**Figure 4 Soils Map.**

Restoration activities will occur primarily in Palms Muck (Pa).

Based on the Soil Survey of Erie County, New York (USDA Official Soil Series Descriptions) the soil series mapped on-site include Canandaigua silt loam, Palms muck, and Varysburg gravelly loam. A soils map is provided in Figure 4. Soil conditions in the field appear to conform to the mapped soil series. Additionally, soil borings were taken throughout areas potentially suitable for restoration work. Descriptions of soil borings are provided in the work plans for the Site in Appendix B. Overall soils appear suitable for shallow grading and ditch plug construction.

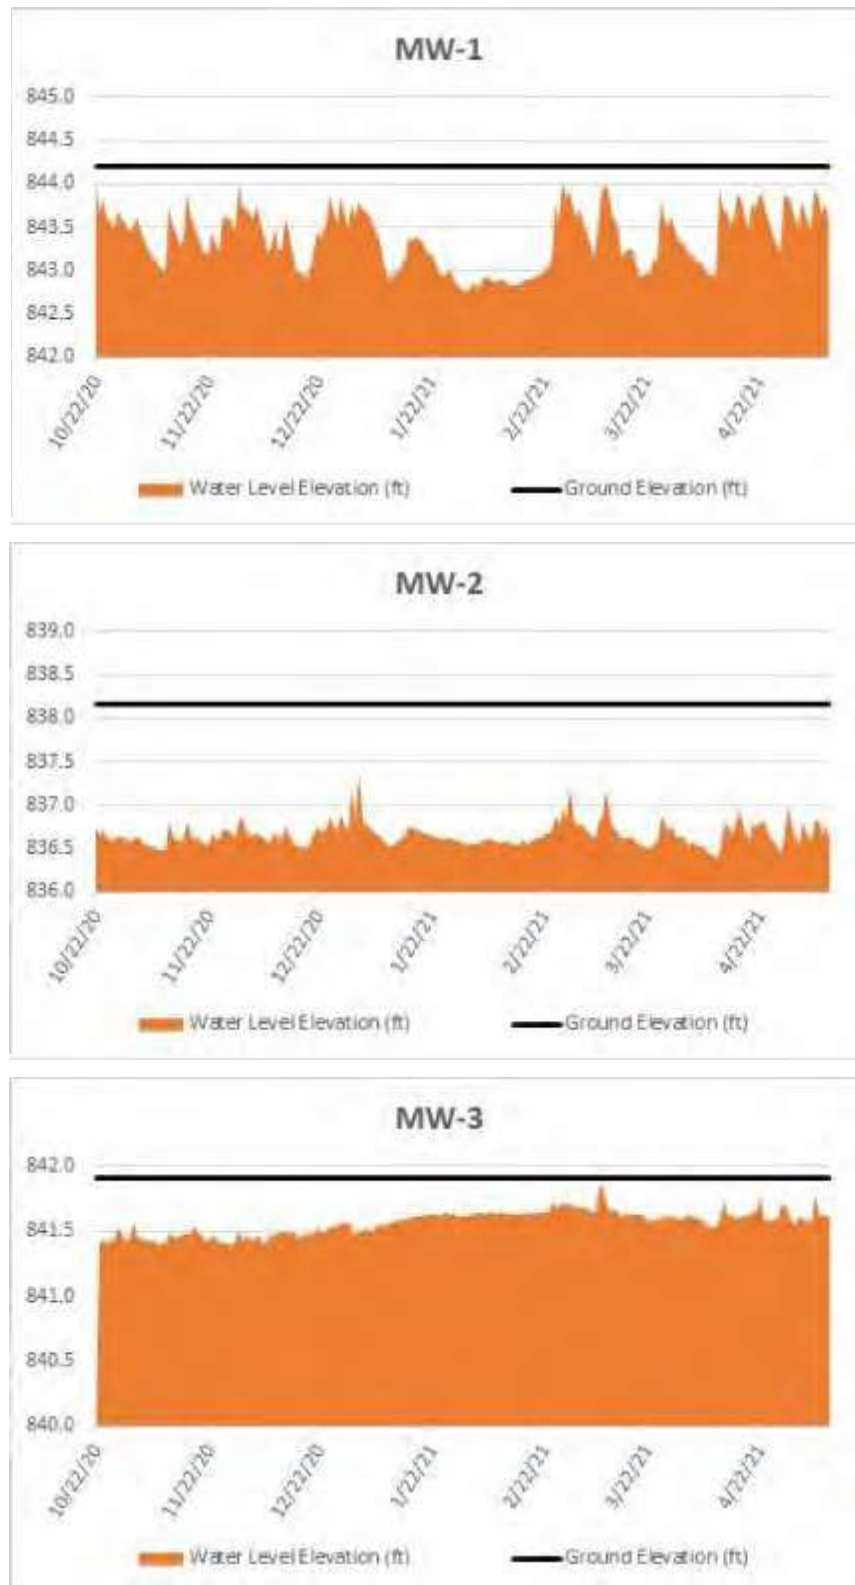
**Figure 5 Ground Water Data.**

Groundwater data is shown from October 2020 to May 2021. The water-table was often observed within 6"-18" of the surface from fall through spring. Dry conditions in 2020, combined with existing drain tile likely prevented groundwater levels from being higher.

The wetland re-establishment and rehabilitation areas are being monitored with three continuously logging water level monitoring wells which commenced in October 2020 (Figure 5). The temporal record of pre-construction conditions is expected to provide 3 full years of baseline data from which to compare pre-vs. post construction hydrology. This record will be augmented with manual water-level measurements in the rehabilitation area to be performed at an additional staff gauge/well location to be installed post-construction. Monitoring locations are shown in Appendix B. Moreover, photo-points included in these areas will provide the ability to qualitatively assess the retention of hydrology compared to baseline conditions to augment quantitative methods.

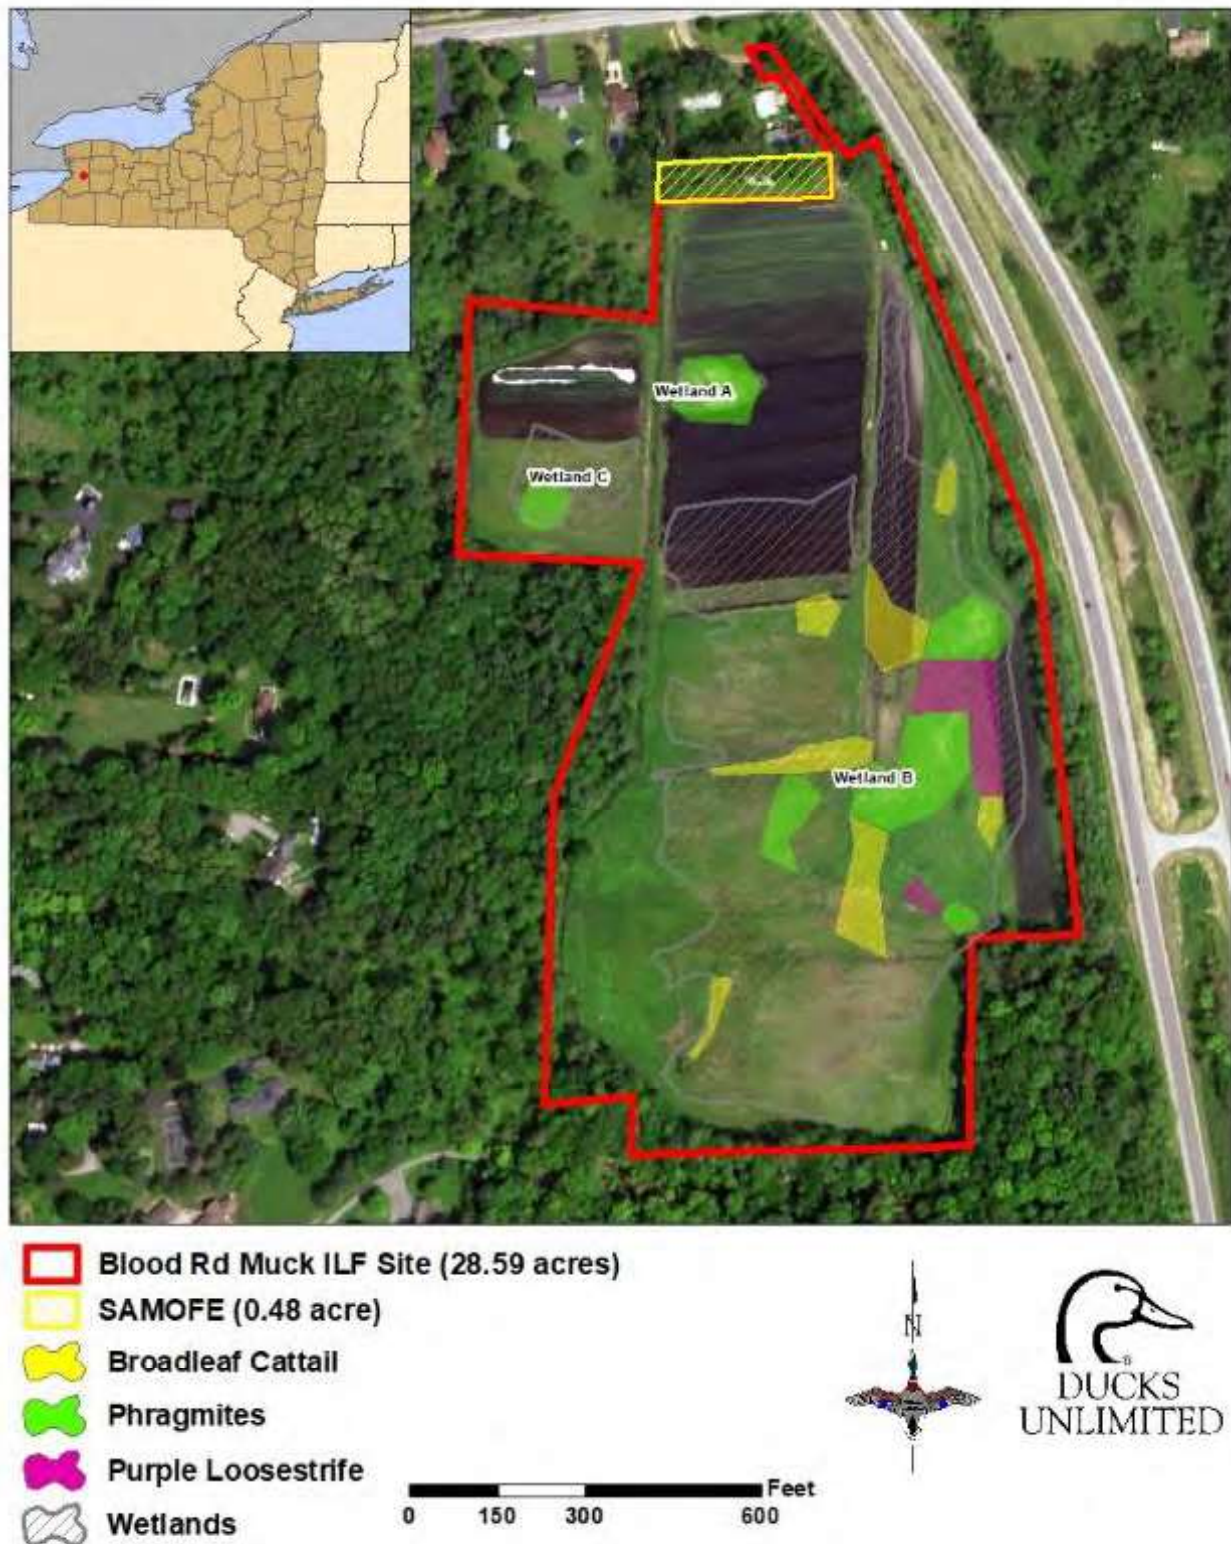
**Figure 6 Invasive Species Map.**

Invasive plant species will be targeted in construction and through adaptive management activities.

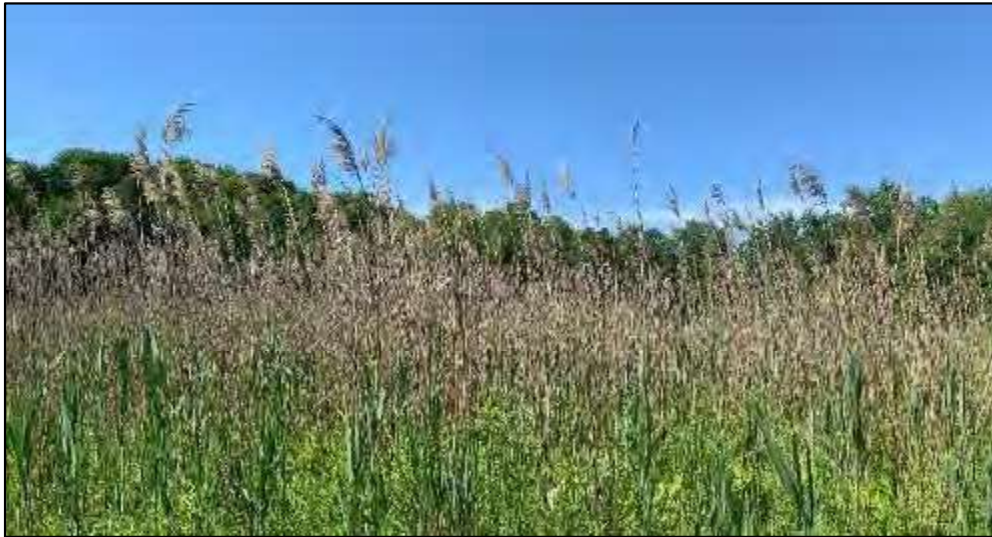
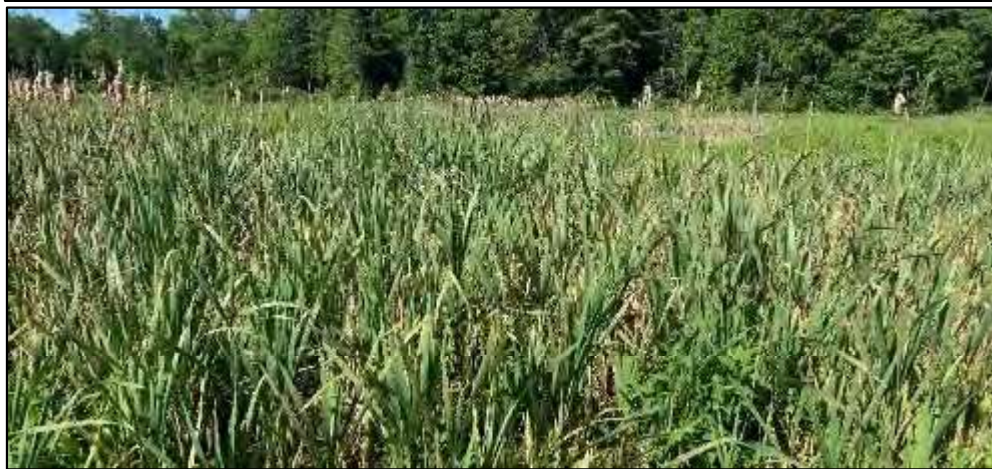
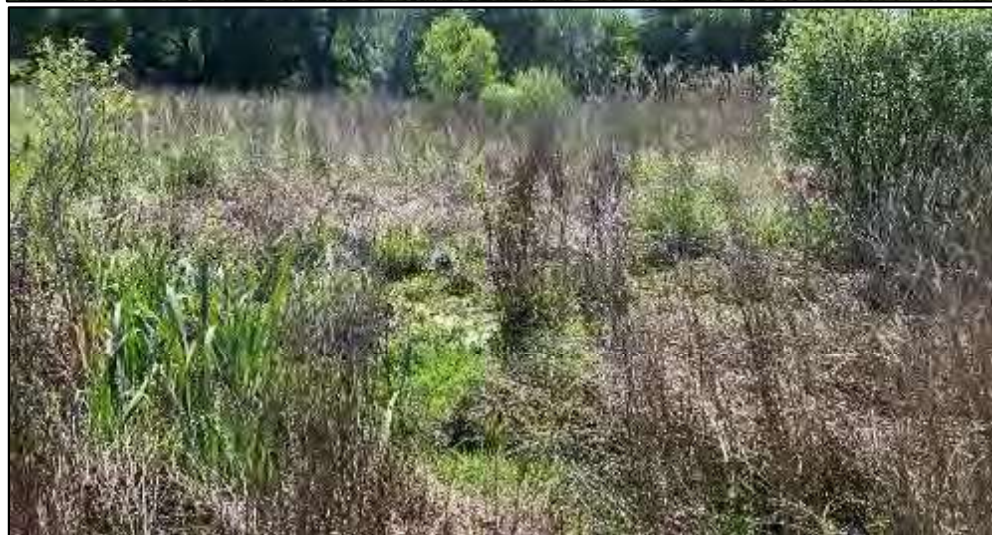
Wetland B contains several stands of *Phragmites australis*, purple loosestrife, and broad-leaf cattail, this area will be mowed and sprayed during construction activities and seeded to a native plant mix. Photos taken June 9, 2020.

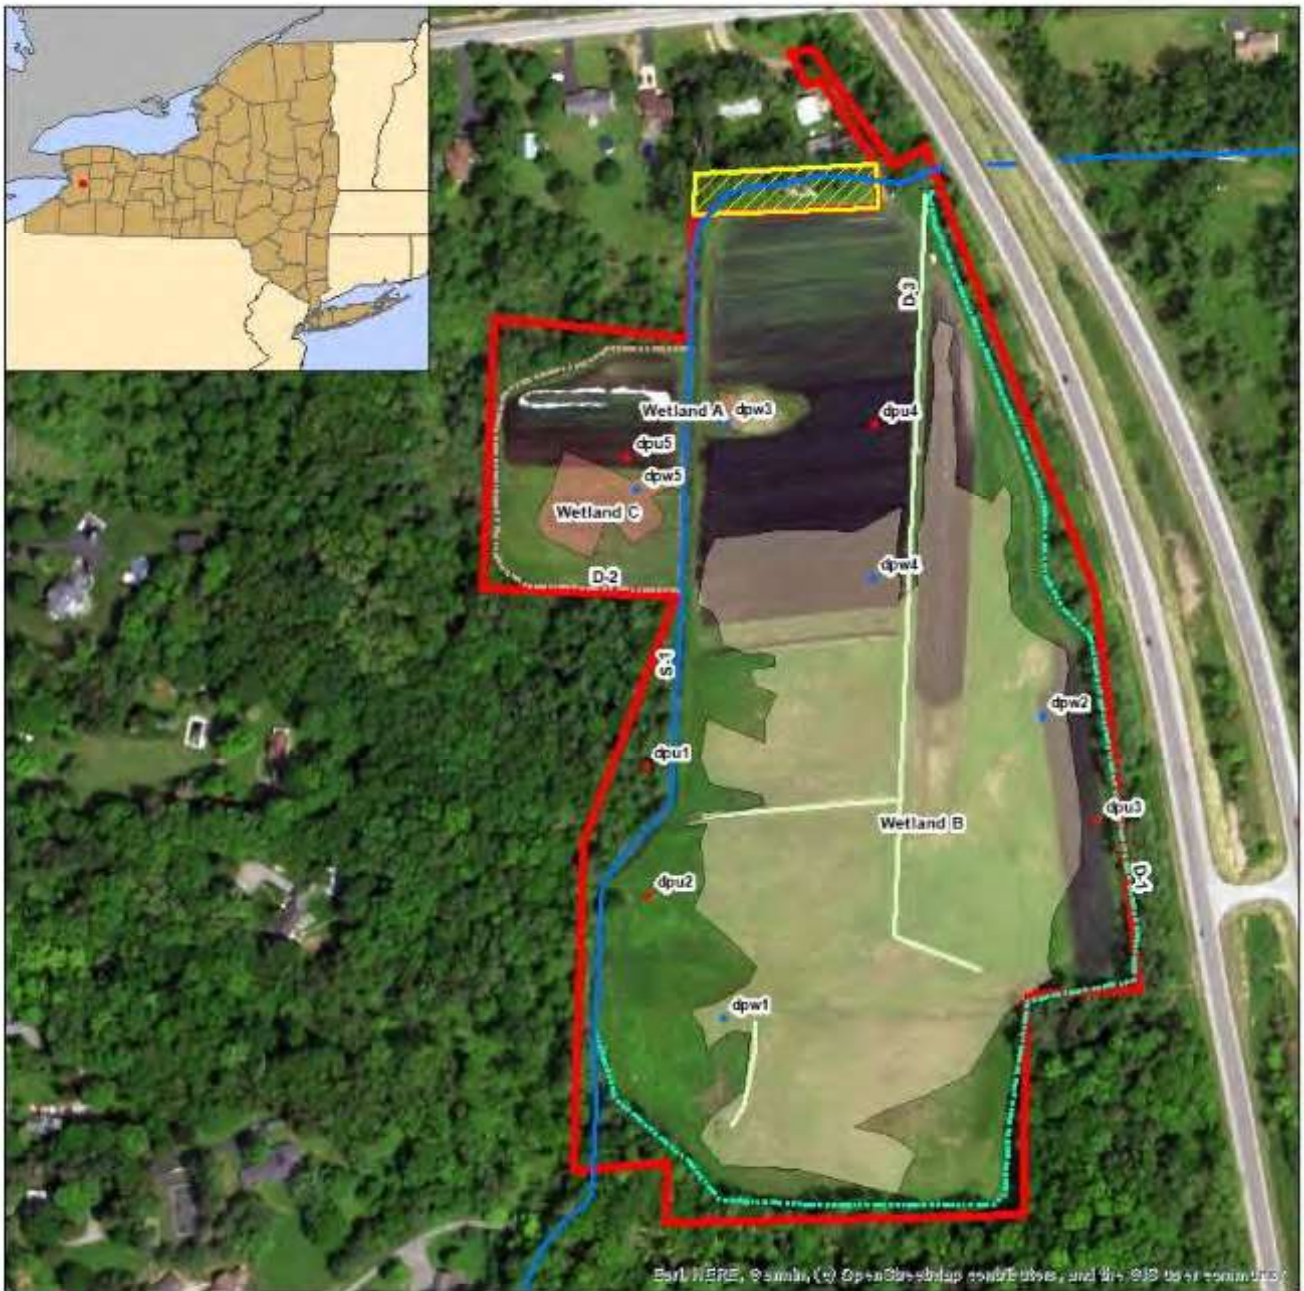
- Blood Rd Muck ILF Site (28.59 acres)
- SAMOFI (0.48 acres)
- Degraded PEM (11.95 acres +/-)
- PEM (0.56 acres +/-)
- Upland Data Point
- Wetland Data Point
- NYSDEC Stream (1,920 feet +/-)
- Main Perimeter Ditch (2,648 feet +/-)
- Perimeter Ditch (908 feet +/-)
- Interior Ditch (1,821 feet +/-)

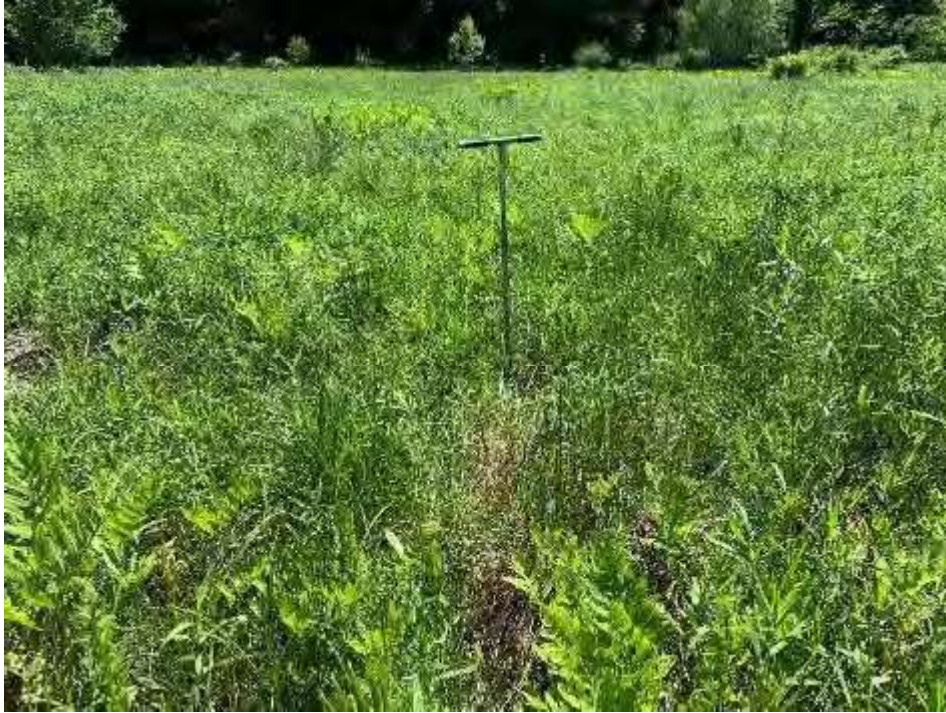
DPW1. This portion of emergent wetland B was dominated by soft rush (*Juncus effusus*), bristly sedge (*Carex comosa*), and sensitive fern (*Onoclea sensibilis*). Primary hydrology indicators included high-water table and saturation. A histosol was the hydric soil indicator.

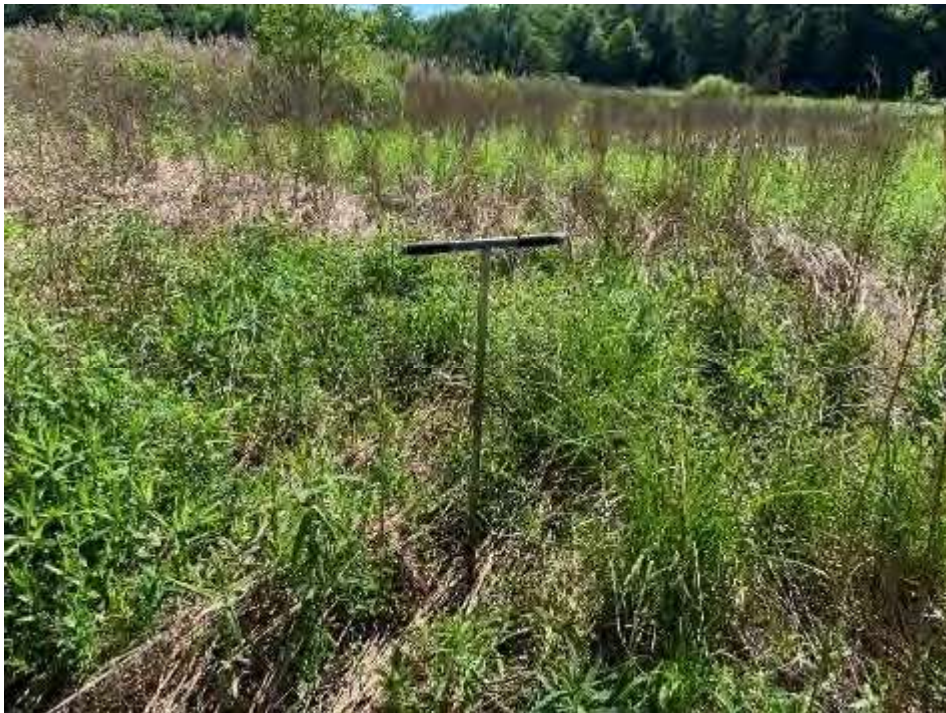
DPW2. This portion of emergent wetland B was dominated by bristly sedge (*Carex comosa*) and purplestem aster (*Symphyotrichum puniceum*). Primary hydrology indicators included high-water table and saturation. A histosol was the hydric soil indicator.

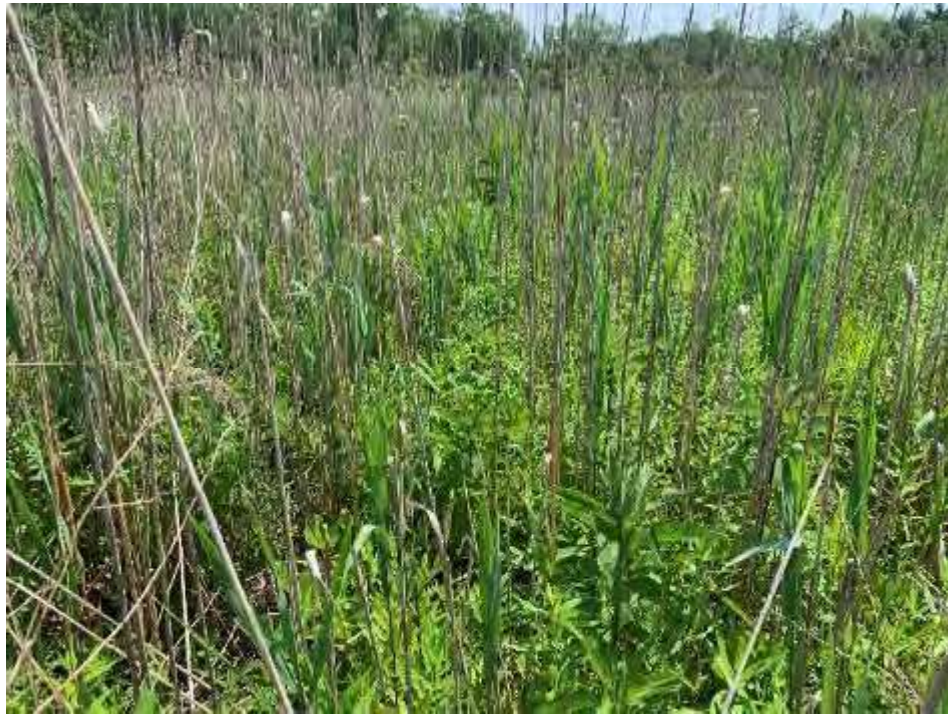
DPW3. Emergent wetland A was dominated by sensitive fern (*Onoclea sensibilis*) and common reed (*Phragmites australis*). Primary hydrology indicators included high-water table and saturation. A histosol was the hydric soil indicator.

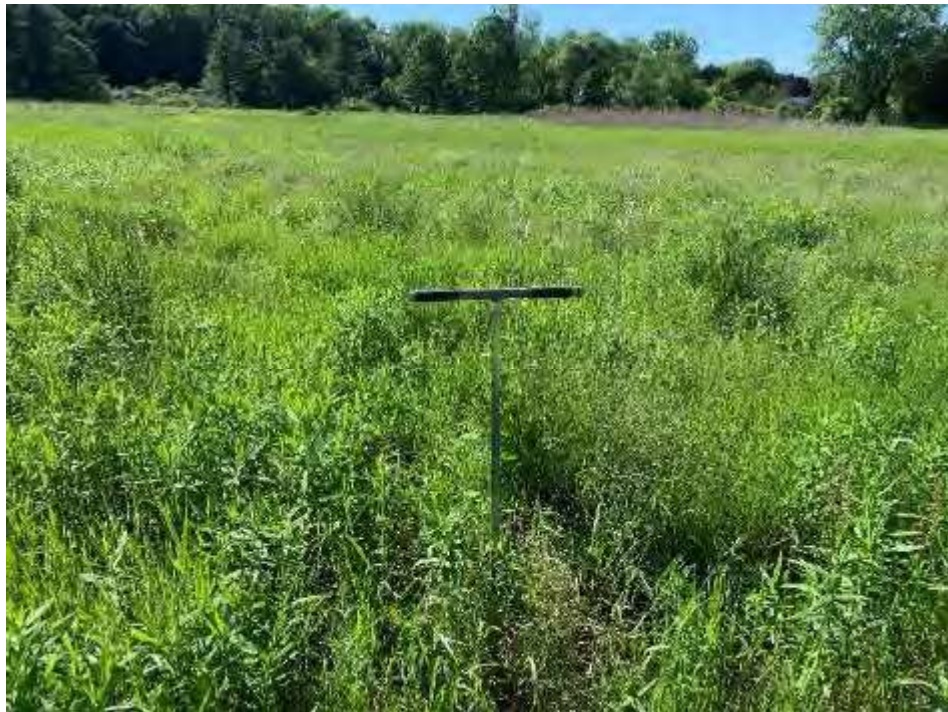
DPW4. This portion of emergent wetland B was dominated by rough bentgrass (*Agrostis scabra*) and purplestem aster (*Symphyotrichum puniceum*). The primary hydrology indicator was saturation. A histosol was the hydric soil indicator.
